CHALLENGE:

Identifying Deformities in 500L Drums

Sellafield Ltd would like to explore techniques and technology which will enable them to accurately measure the dimensions of waste drums used for long-term storage, and identify any deformities.

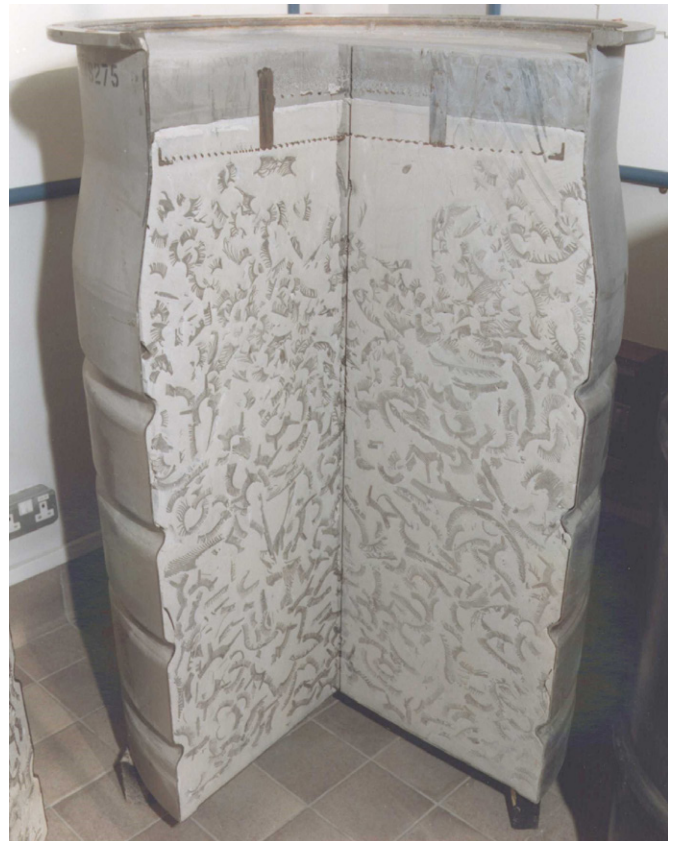
Figure 4 – Cut away of a replica 500L drum showing waste material encapsulated in grout. It should be noted that in this example the waste is evenly distributed within the grout, whereas normally the waste tends to settle towards the bottom of the drum

Figure 3 shows the inside of the MEP as seen through the shielded viewing window and Figure 4 depicts a cut-away dummy 500L drum that has been filled with encapsulated waste.

During the grouting process, uranium containing waste materials settle in the lower section of the drum. It is therefore reasonable to expect that deformities due to corrosive expansion are more likely to develop in the lower section of the drums.
