# Internal inspection of long and narrow pipework

Sellafield Ltd seeks a technology capable of conducting internal visual inspection of long, narrow, convoluted pipework, providing live HD colour video to assess condition, identify any defects, and manage the risk of failure.

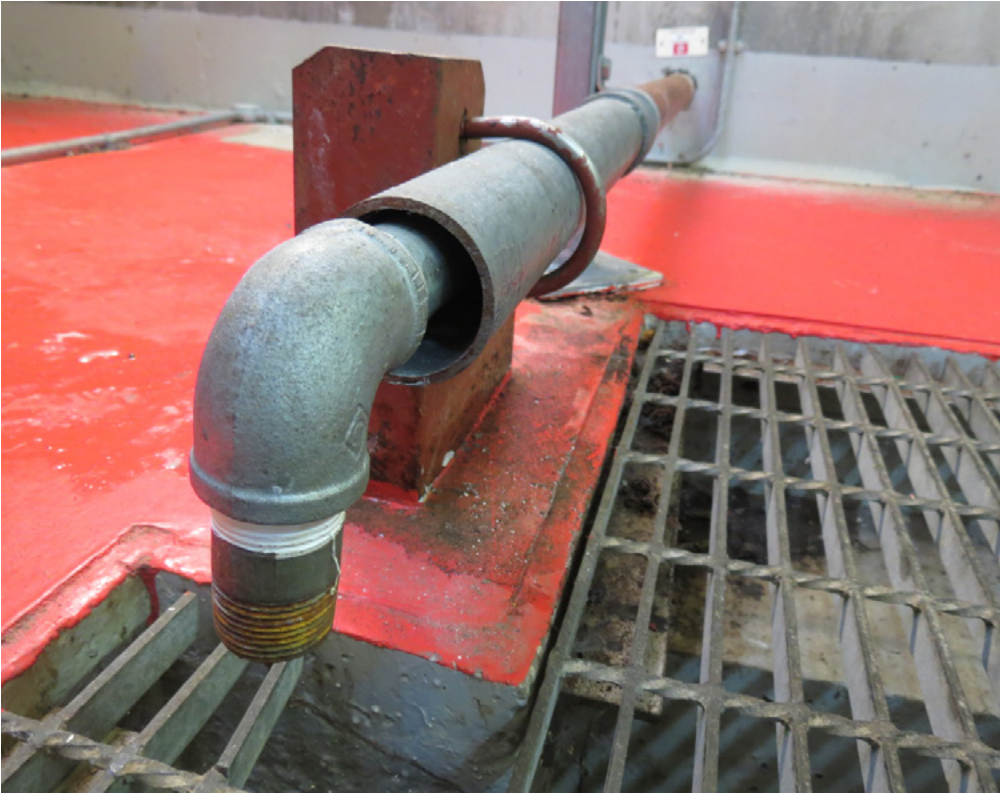
*Figure 1.2: Close-up of access.*

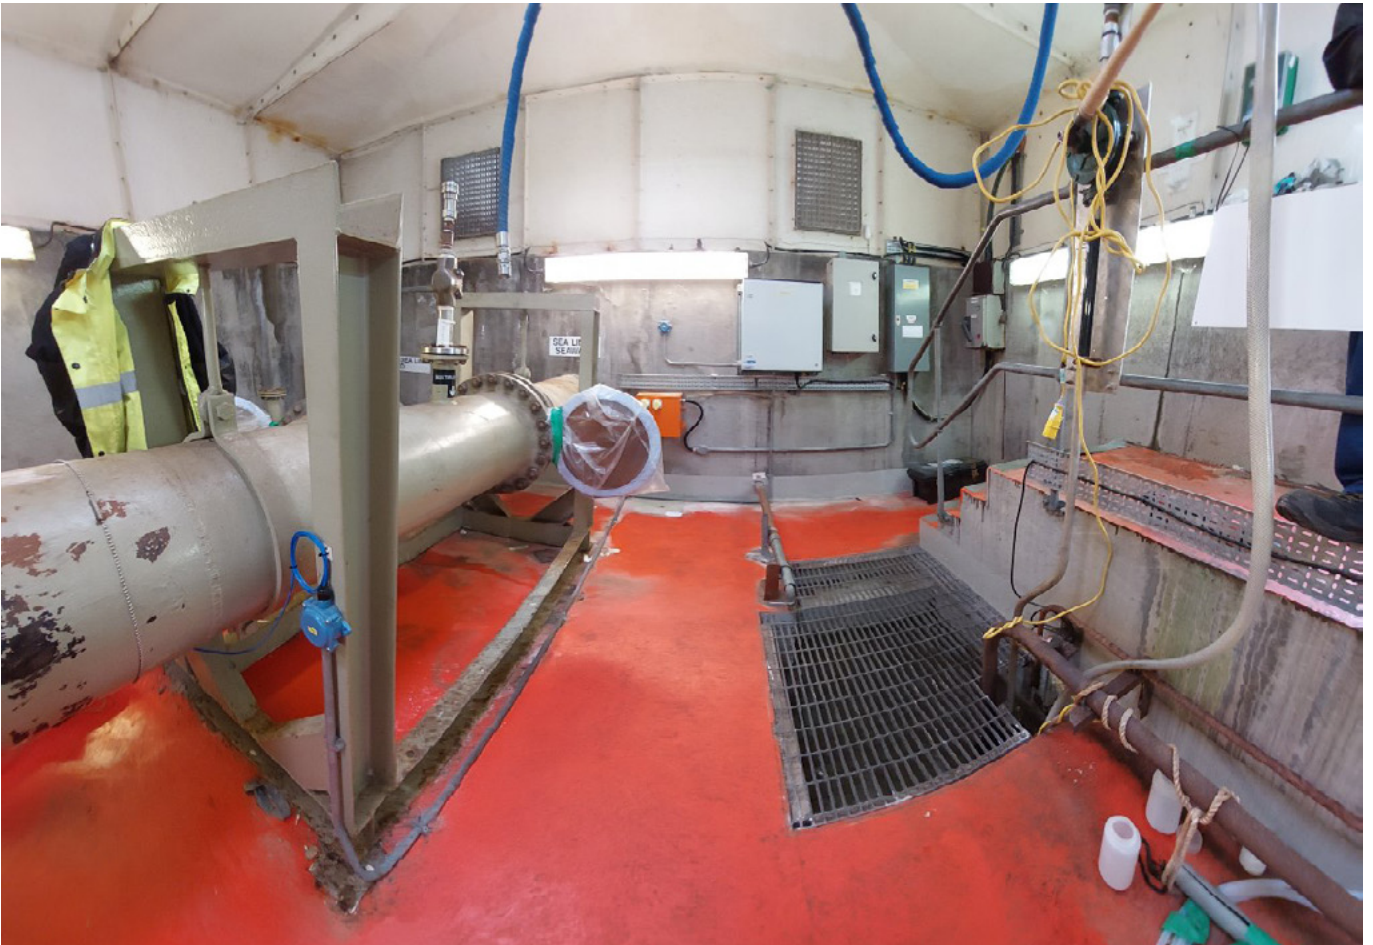
*Figure 2: Image of working space.*

- Solution must be designed to consider contamination control.
- There is roughly 154cm x 152cm flat surface space in front of the pipe for deploying any solution. The end of the pipe is housed within a hut with steps down, a part metal grid floor, and other pipework present (Figure 2).

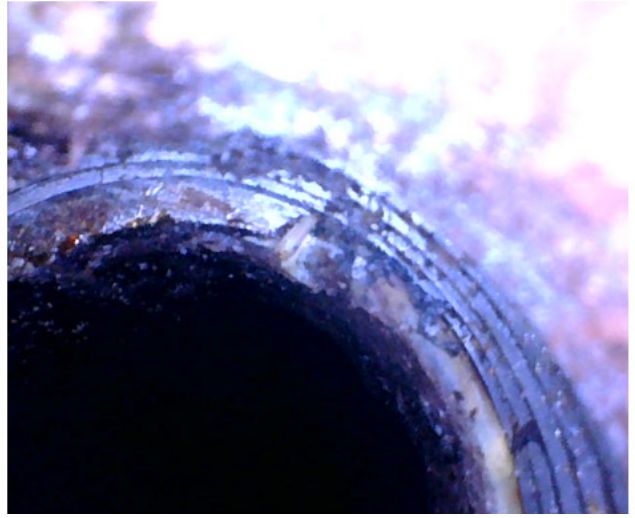
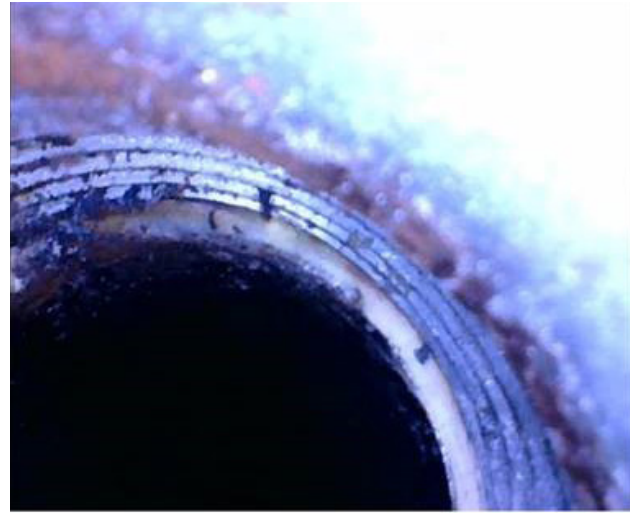
*Figure 4: Example images of threaded section.*

- Pipework is narrow, down to 20mm internal diameter.
- Internal restrictions or artifacts, such as threaded areas or welds.
- Internal pipe surface is not smooth, with general surface corrosion and localised area of loose corroded material and delamination.
